SEISMIC HAZARD INVESTIGATION – FAULT STUDY MULTI-FAMILY RESIDENCES PROJECT 6400 CHOCOLATE DRIVE SUN VALLEY, RENO, NEVADA APN 502-250-09

> PROJECT NO. R20215772E2 September 9, 2022

RE: Seismic Hazard Investigation – Fault Study Multi-Family Residences Project 6400 Chocolate Drive Sun Valley, Reno, Nevada APN 502-250-09

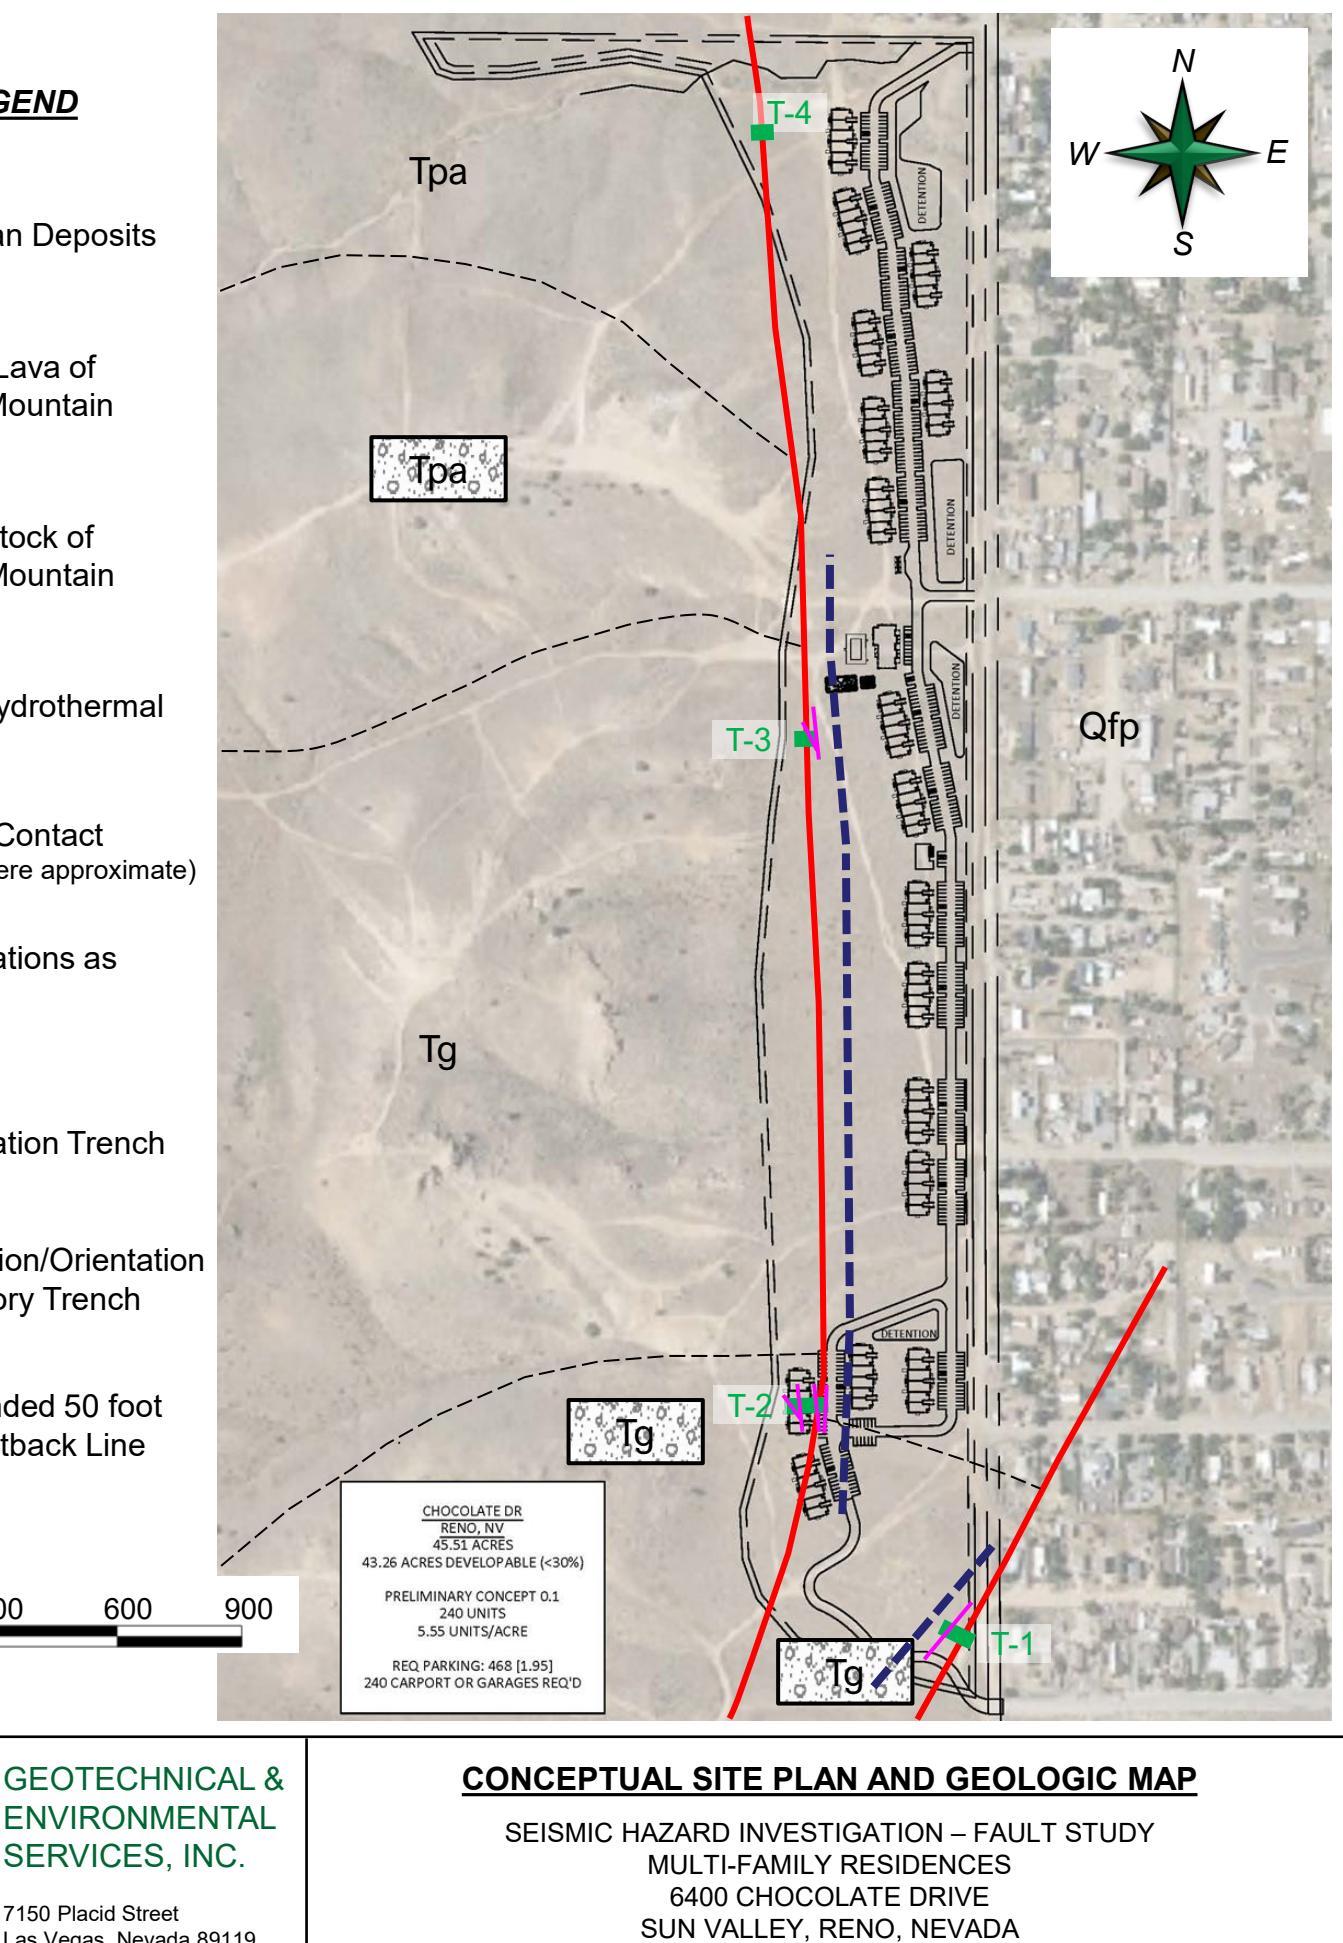
indications of fault surface ruptures were observed on or immediately adjacent to the project site, surficial geologic features (i.e., eroded scarps) were interpreted generally in the western portion of the site. Our interpretation of site geologic and physiographic features at the project site are presented on Figure 3, Conceptual Site Plan and Geologic Map.

Fault Locations as Mapped

Fault Location/Orientation in Exploratory Trench

Recommended 50 foot **Building Setback Line**

As per the Nevada Earthquake Safety Council "Guidelines for Evaluating Potential Surface Fault Rupture/Land Subsidence Hazards in Nevada"; Minimum set-back distances from known faults and fissures for occupied structures from Holocene active faults shall be fifty (50) feet. Furthermore, no critical facility shall be placed directly over the trace of a Late Quaternary active fault.

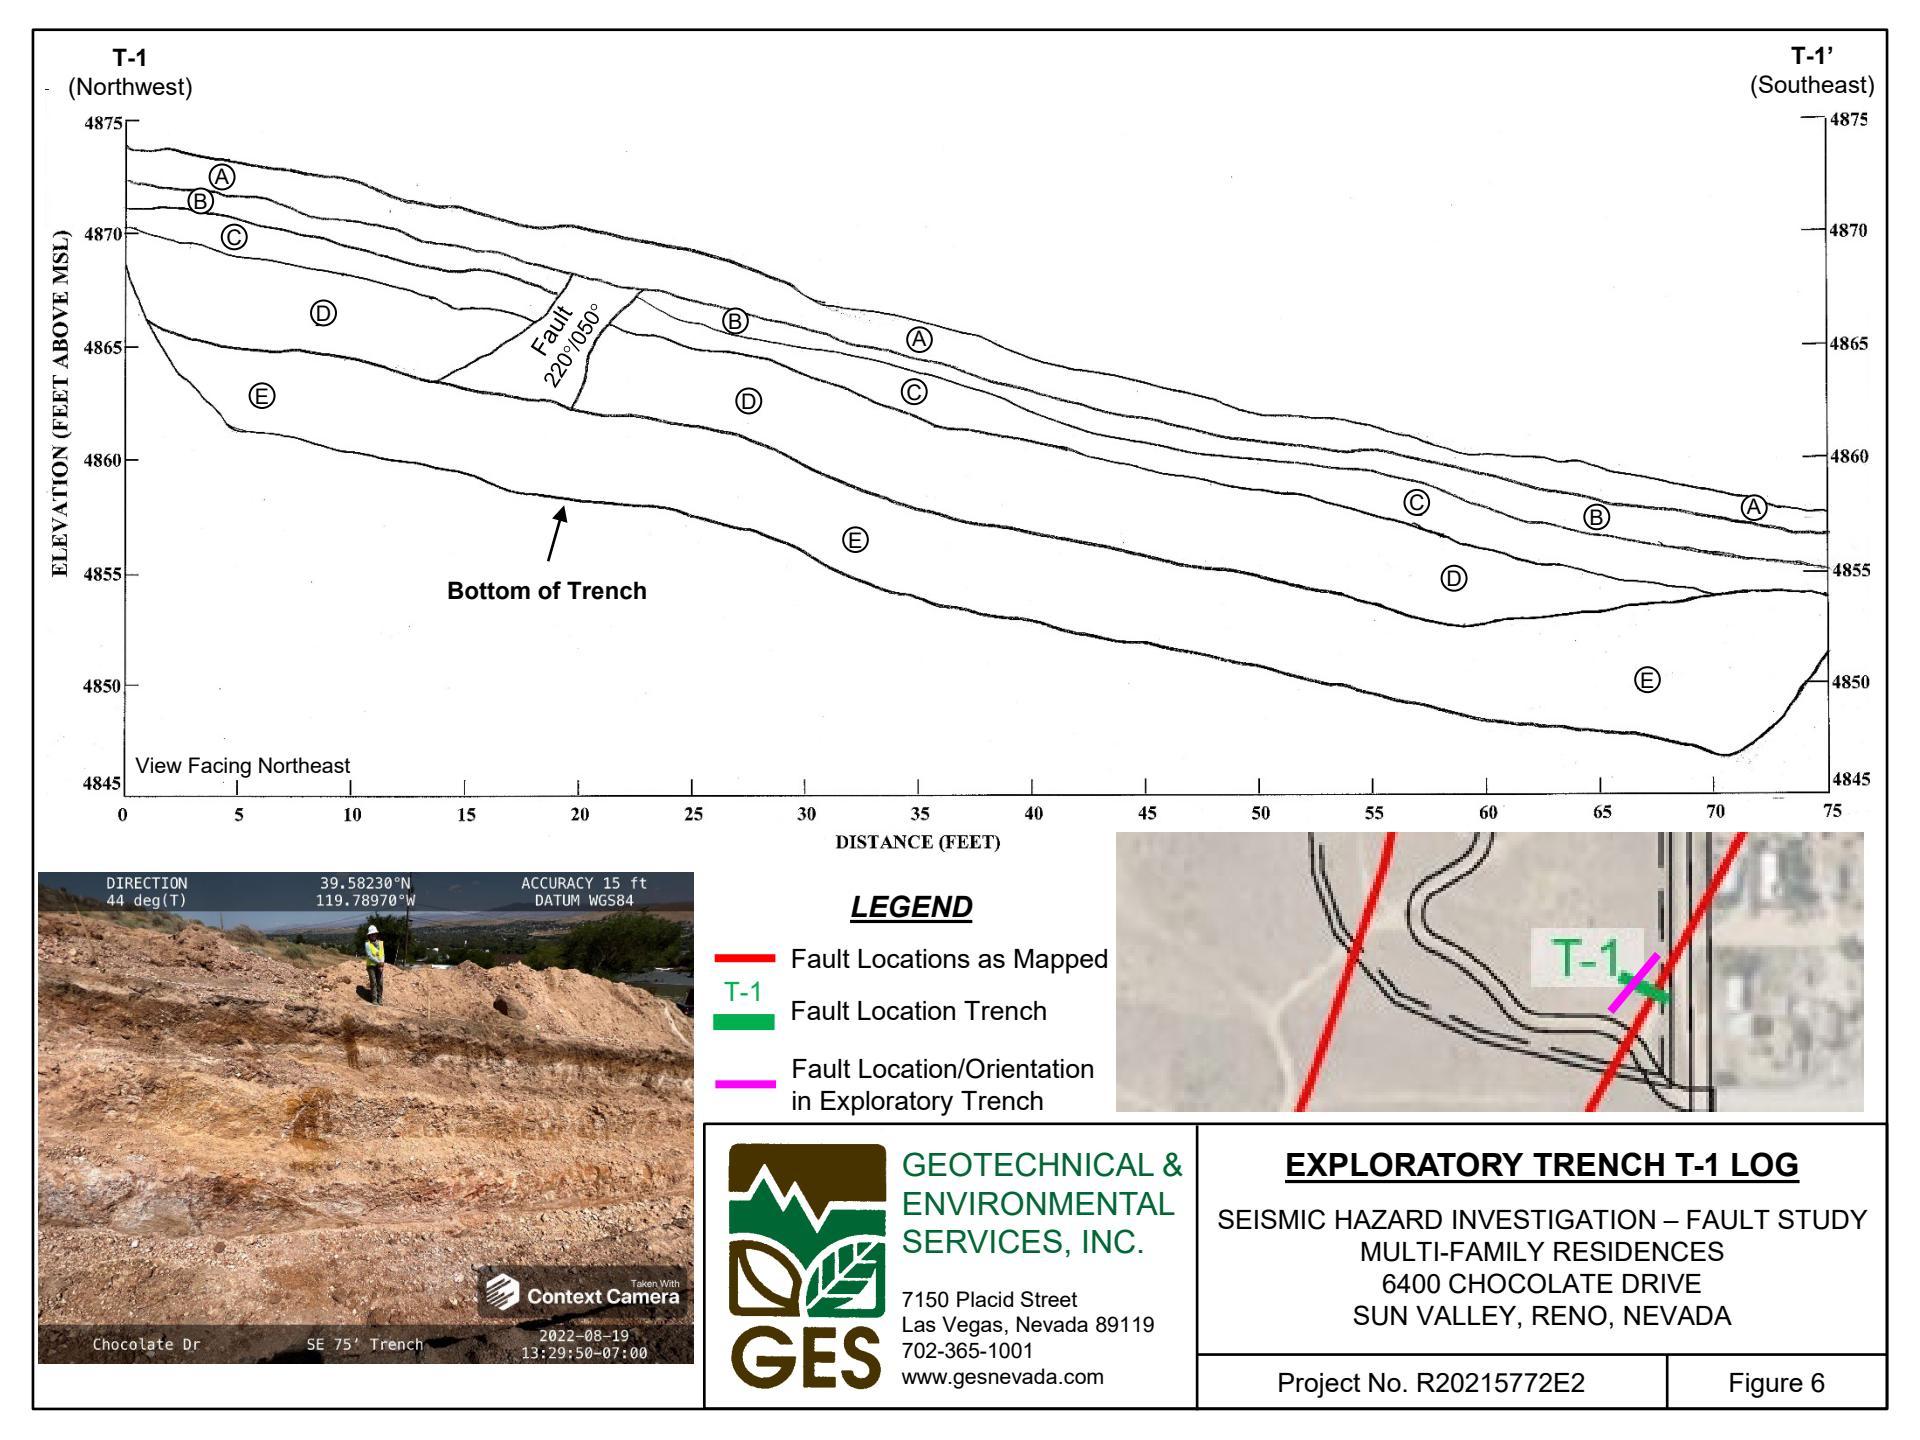
Soils observed in Trench 1 consisted primarily of silty/sandy clays with fine gravels to approximately 4 feet bgs, underlain by sandy clay with occasional highly weathered hydrothermally altered andesite cobbles to approximately 8 feet bgs. These units were further underlain by hydrothermally altered bedrock. Minor distortion of lateral soil continuity as well as a section of fault gouge with remineralized edges, i.e., evidence of faulting, was observed within Trench 1's units B, C, and D; the continuation of the fault was lost in the hydrothermally altered bedrock (unit E). Faulting was not observed to continue into unit A (i.e., the upper  $\pm 1 - 2$  feet). The fault was measured to have a strike of 220° with a dip of 050° and varied in width from 3 feet to 6 feet.

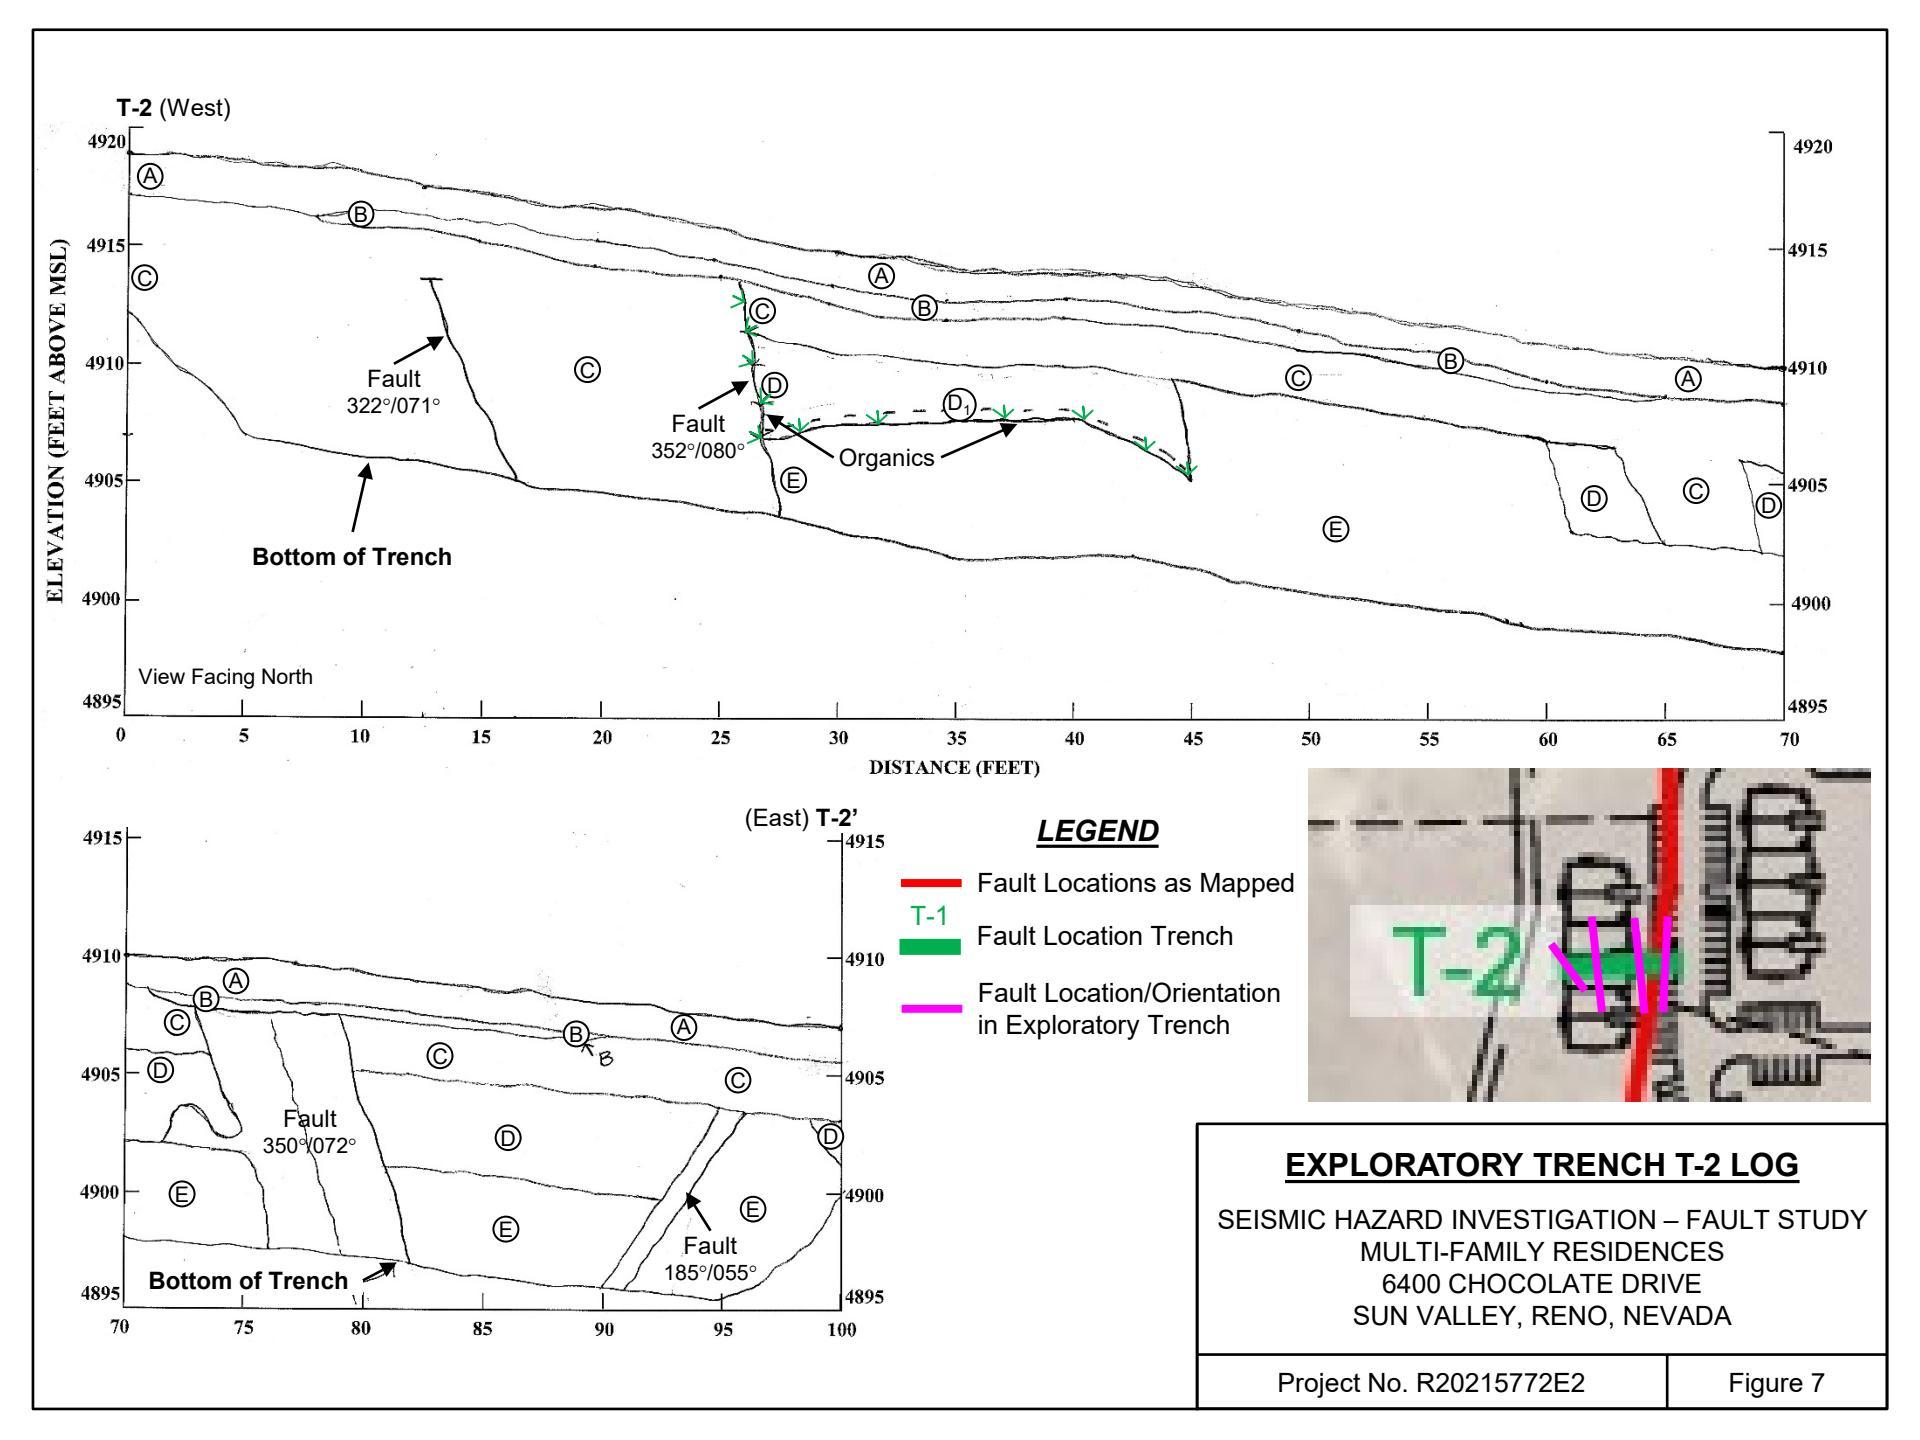
Soils observed in Trench 2 consisted primarily of sandy clays with gravels to approximately 2 feet bgs, underlain by sandy clay with hydrothermally altered andesite gravel and cobbles to approximately 2 to 12 feet bgs. The above soils were underlain in some areas by weakly to highly cemented sandy clay with angular cobbles, the highly cemented areas were highly fractured; one section had a layer of organics at the base. These units were further underlain by highly cemented and highly fractured silty sand. Minor to major distortion of lateral soil continuity as well as multiple sections of fault gouge with remineralized edges, i.e., evidence of faulting, were observed within Trench 2's units C, D, and E; faulting was not observed to continue into units A and B (i.e., the upper  $\pm 2$  feet). Four faults' orientations (strike/dip) were measured as follows from west to east:  $322^{\circ}/071^{\circ}$ ,  $352^{\circ}/080^{\circ}$ ,  $350^{\circ}/072^{\circ}$ , and  $185^{\circ}/055^{\circ}$ . The faults width varied from a few centimeters wide to approximately 6 feet wide.

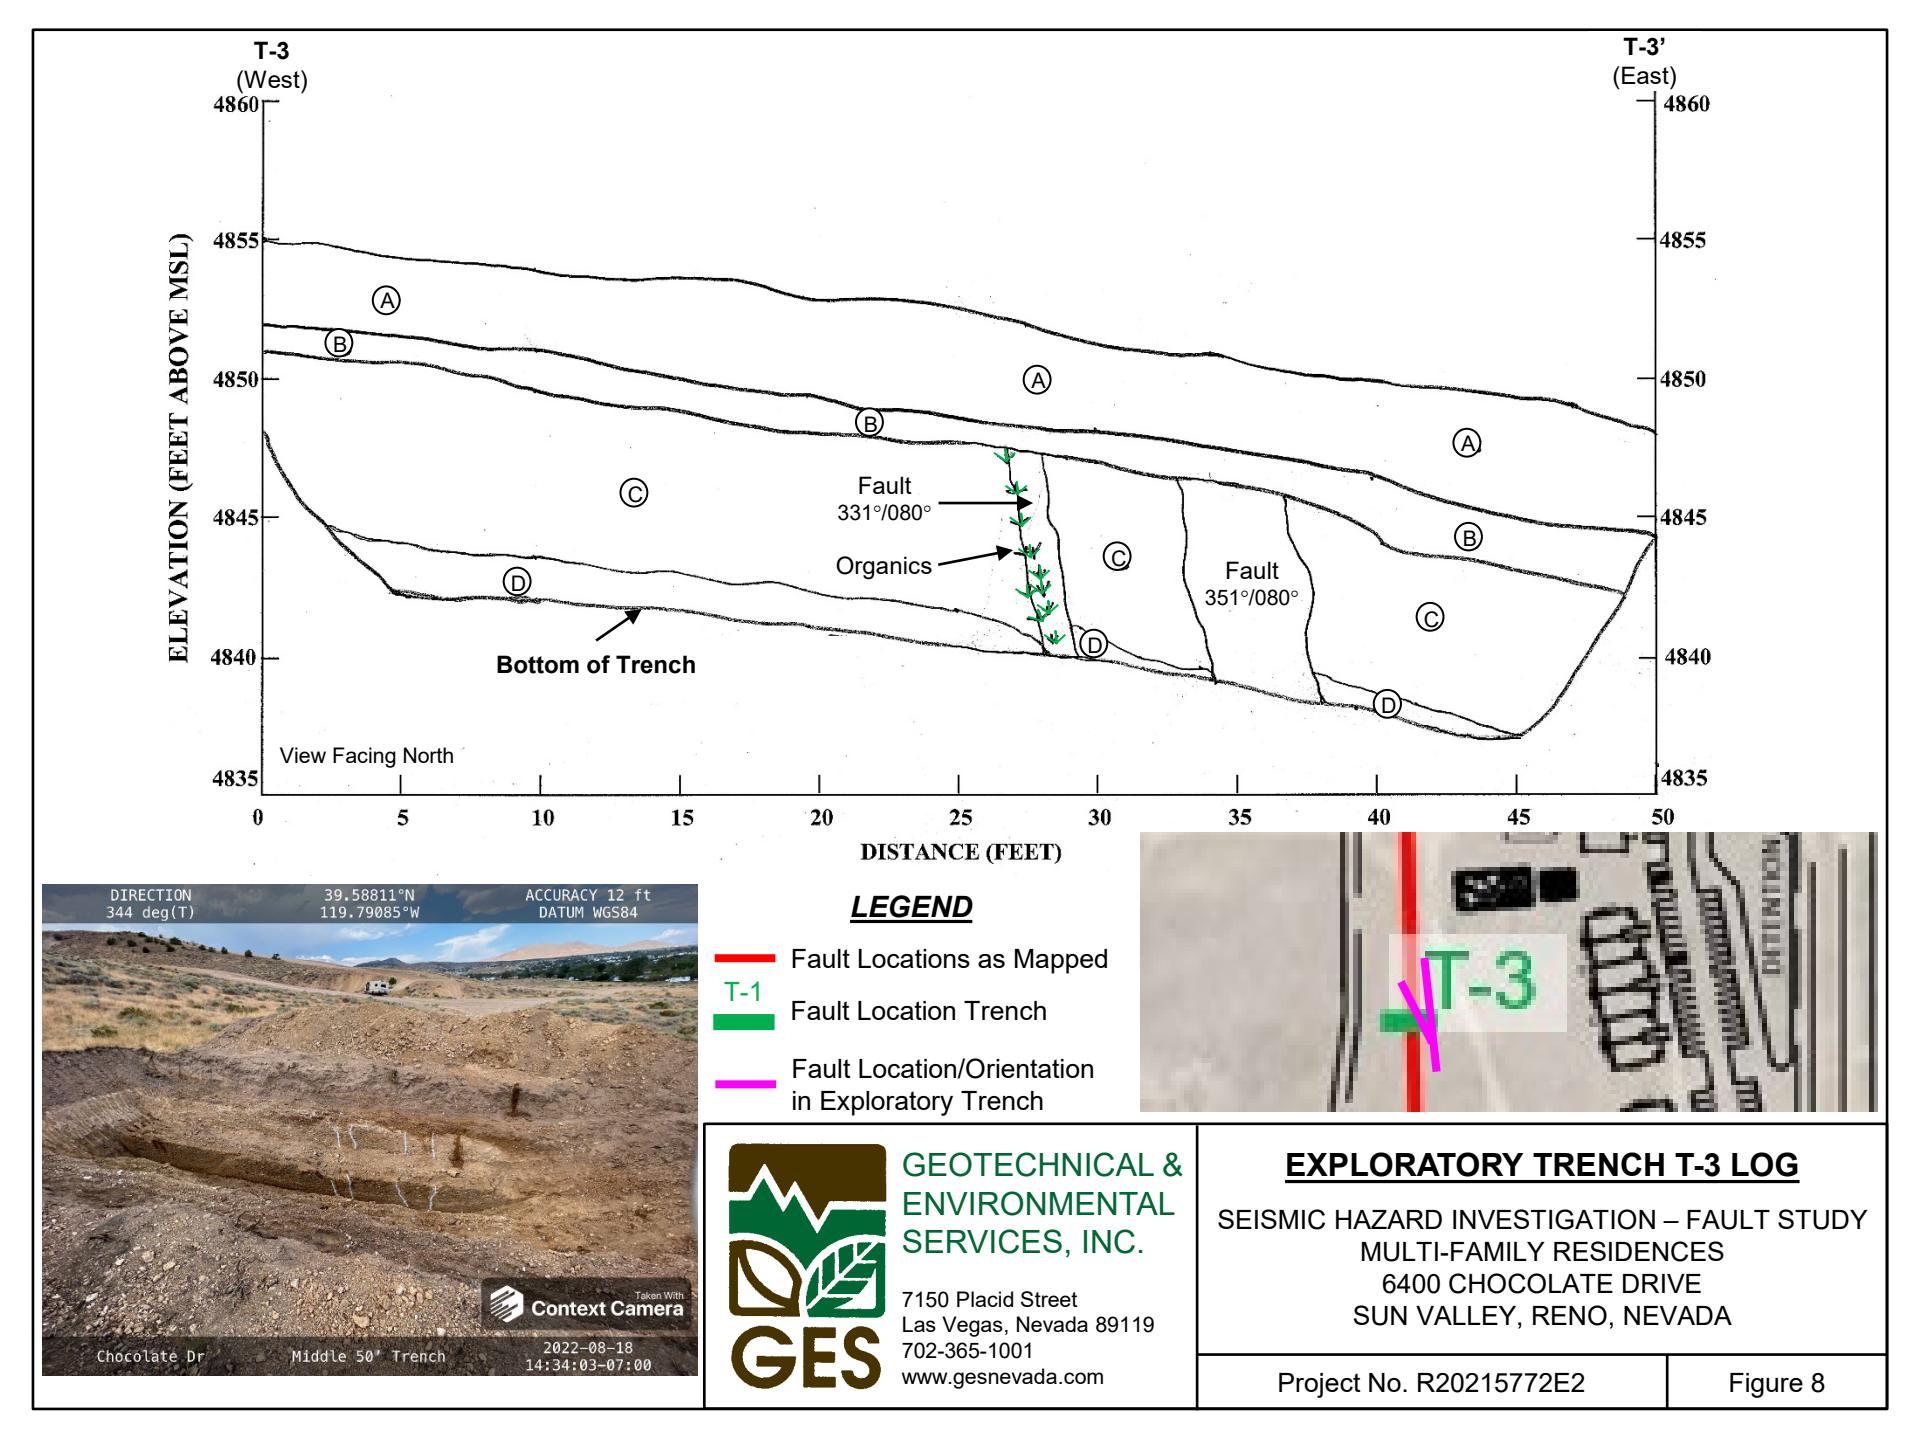
Soils observed in Trench 3 consisted primarily of silty to clayey sand with gravel to clay with sand with gravel to approximately 4 to 12 feet bgs, underlain by silty sand with hydrothermally altered andesite gravel and cobbles to approximately 12 feet bgs. These units were further underlain by clay with silt and fine sand. Minor distortion of lateral soil continuity as well as sections of fault gouge with remineralized edges, i.e., evidence of faulting, were observed within Trench 3's units

C and D. Faulting was not observed to continue into units A and B (i.e., the upper  $\pm 4$  - 5 feet). Two faults' orientations (strike/dip) were measured as follows from west to east: 331°/080° and 351°/080°. The faults width varied from approximately 2 – 3.5 feet wide.

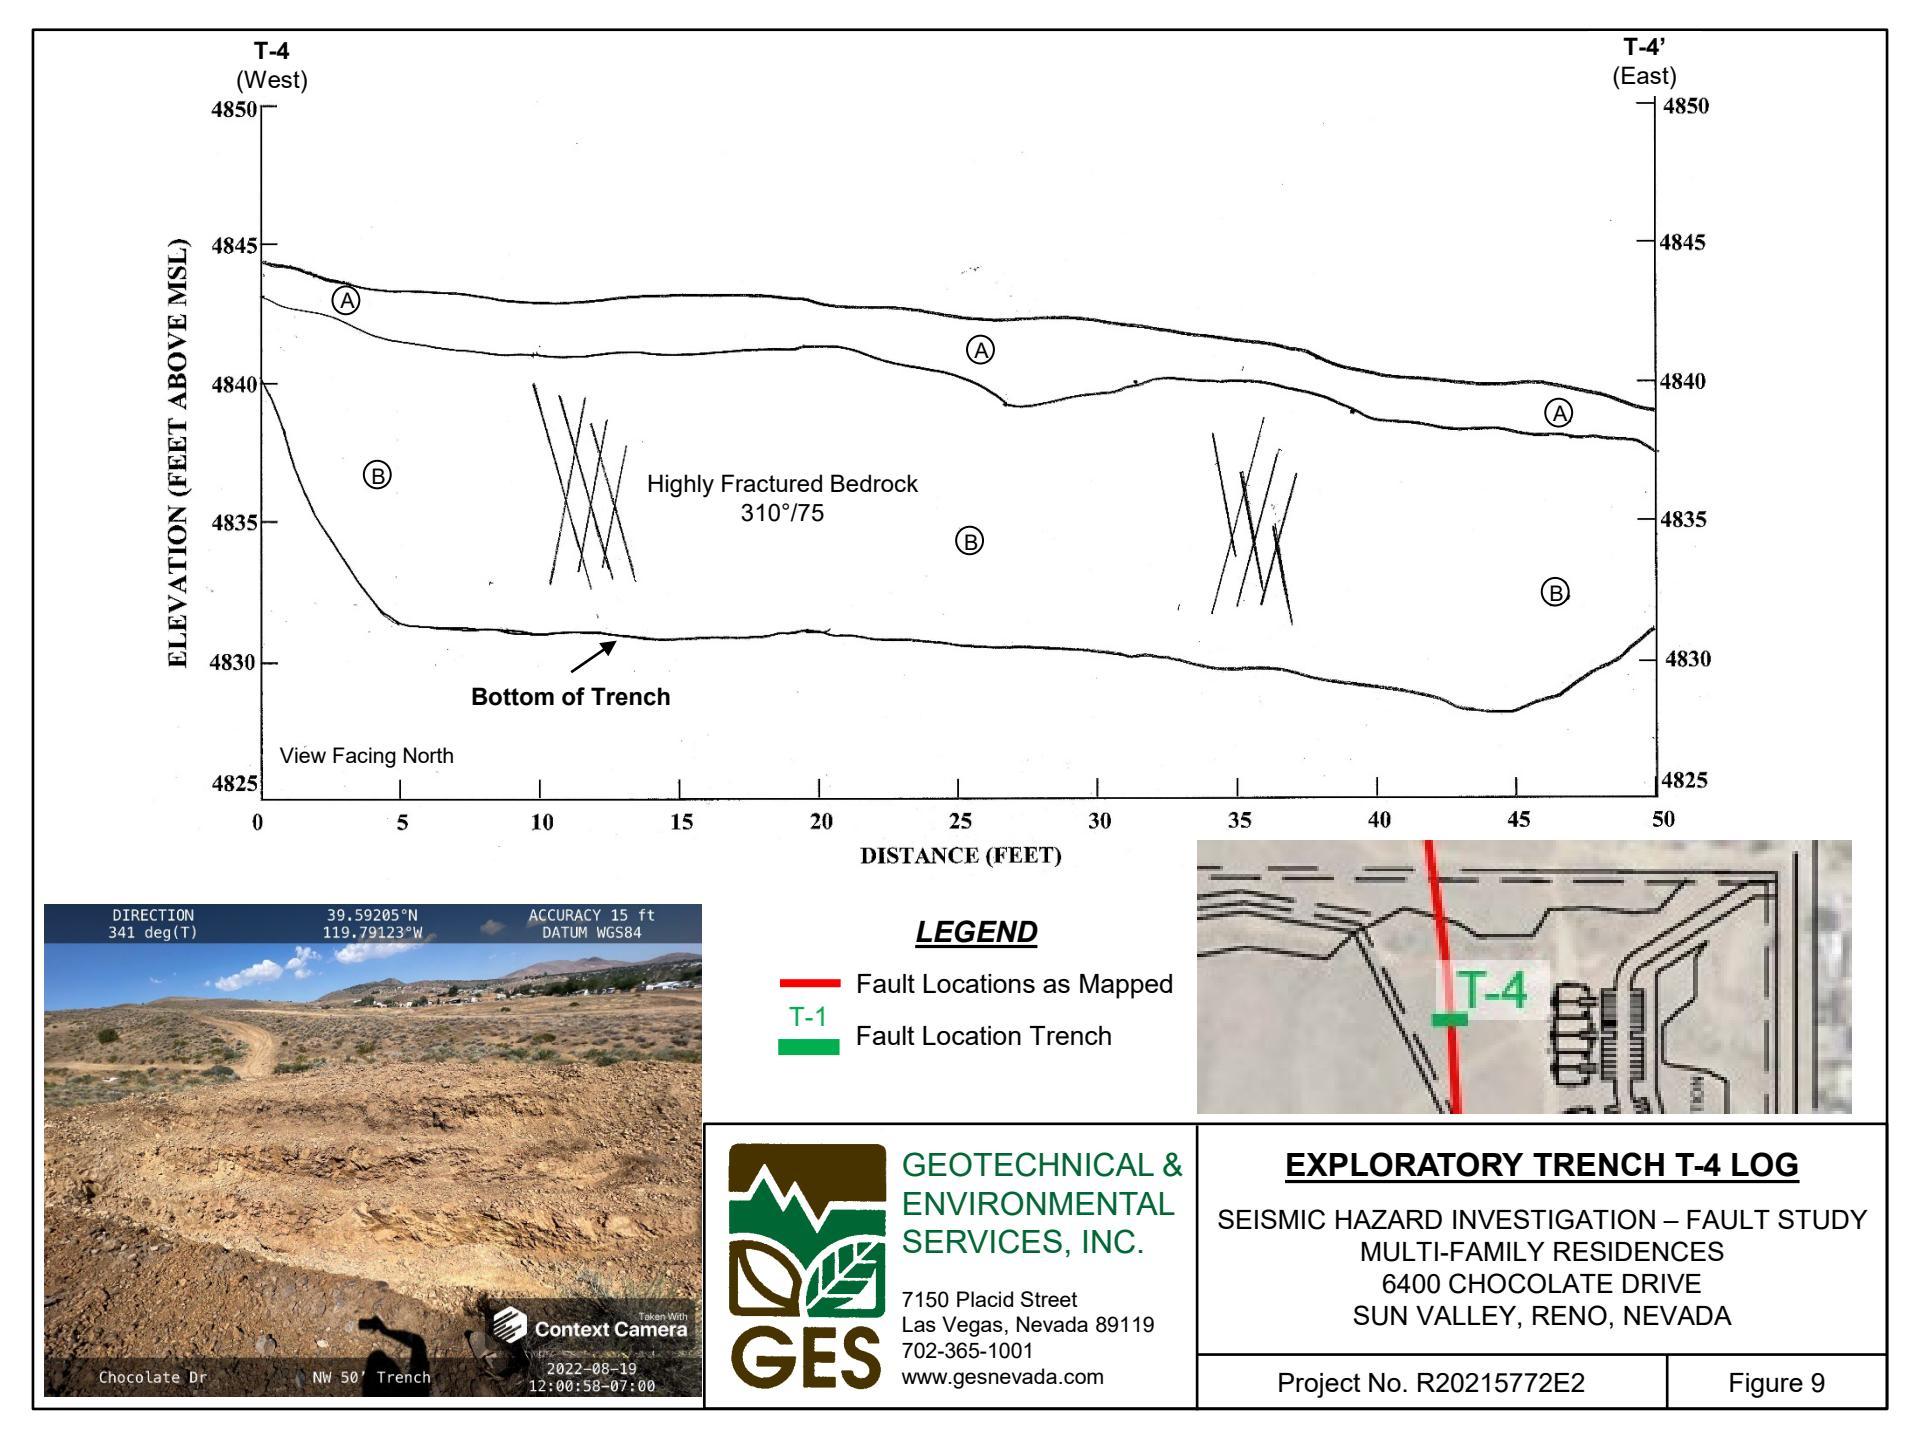
Soils observed in Trench 4 consisted primarily of sandy clay with gravel and cobbles to approximately 1 to 2 feet bgs. This was underlain by intensely fractured basalt bedrock to approximately 12 feet bgs. While no fault related features were observed in Trench 4, it is important to note Trench 4 was mainly comprised of intensely fractured bedrock. The intense fracture patterns may have obscured or even concealed evidence of past faulting. The predominant orientation (strike/dip) of the fractures within the basalt bedrock were measured and are generally oriented 000°/080°.
