Historic Preservation (CEST and EA) - PARTNER

Architectural Inventory Report

Nevada Cares Campus, Phases 3 and 4
November 2022

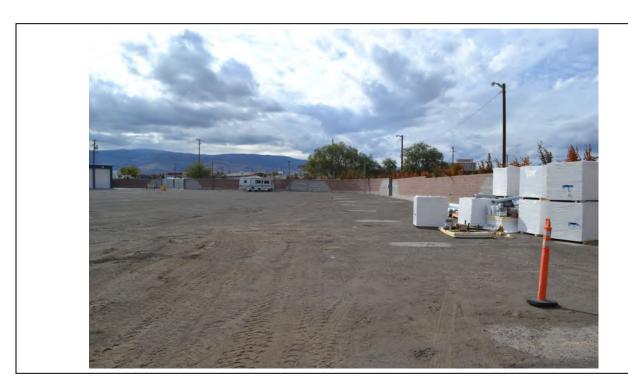
Elevation: Overview of CMU portion of Structure 2 Photographer: S Rathbone Date: 10/2 Direction facing: 240 Date: 10/25/2022

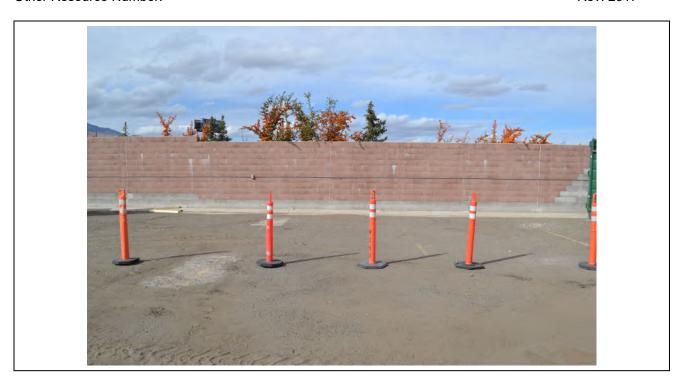
Elevation: Detail of CMU portion of Structure 2 D Photographer: S Rathbone Date: 10/25/2022 Direction facing:330

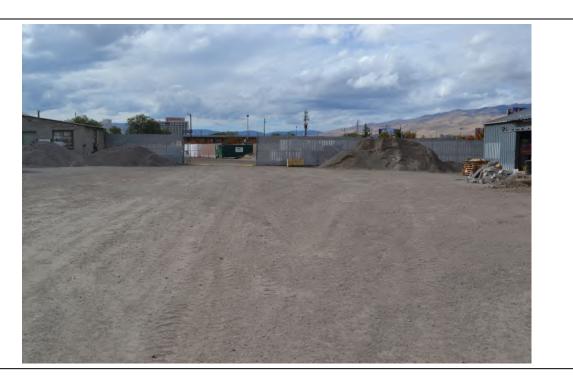
Elevation: Detail of Structure 3 running between Building 2 and Building 4 Photographer: S Rathbone Date: 10/25/2022

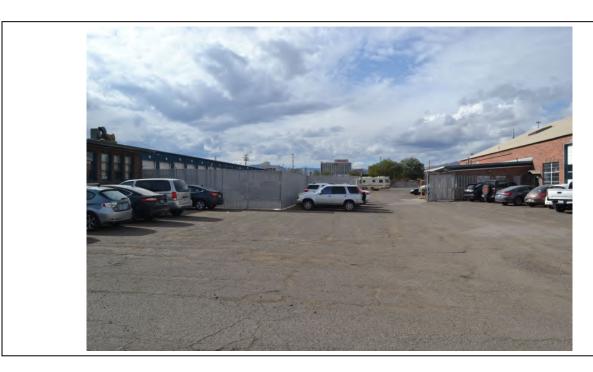
Elevation: Detail of Structure 3 running between B15585 and Building 2 Photographer: S Rathbone Date: 10/4/2022

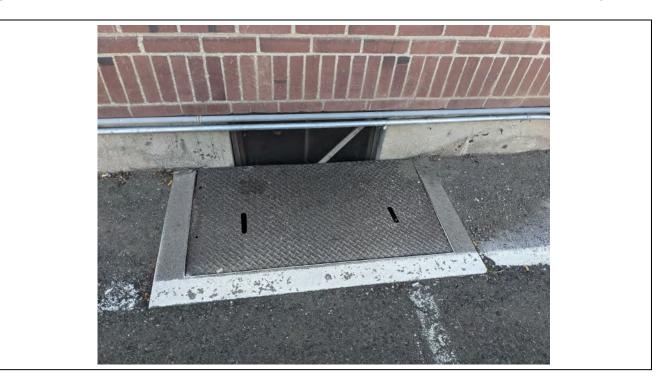
Elevation: B15585 Eastern lightwell on north wall of basement Photographer: S Rathbone Date: 10/4/2022

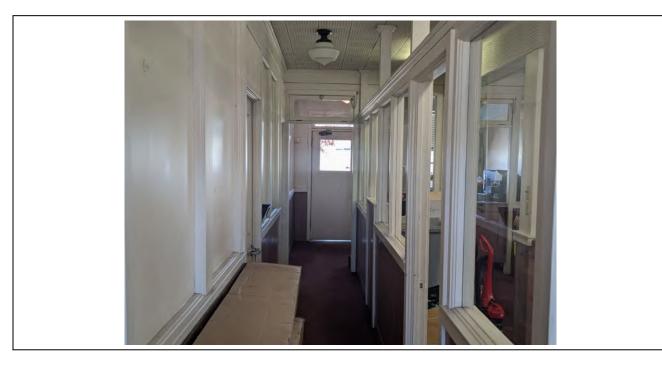
The interior of the building is well preserved, and features a foyer, a passage, a large open plan office to the south of the passage, and three private offices to the north of the passage. Within the large open plan office are a set of restrooms, and a door that opens on to the stairs that lead to the basement. The different internal areas are defined by original wood or wood and glass partition walls, which are in good condition. The interior now features a drop ceiling.

Elevation: B15585 Detail of largely intact interior

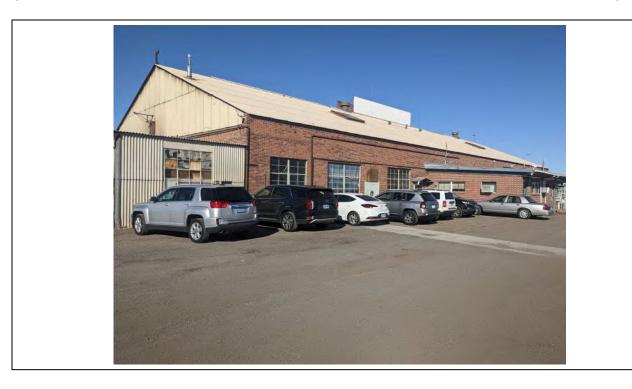
Elevation: Building 2 South elevation Date: 10/4/2022 Direction facing: 50 Photographer: S Rathbone

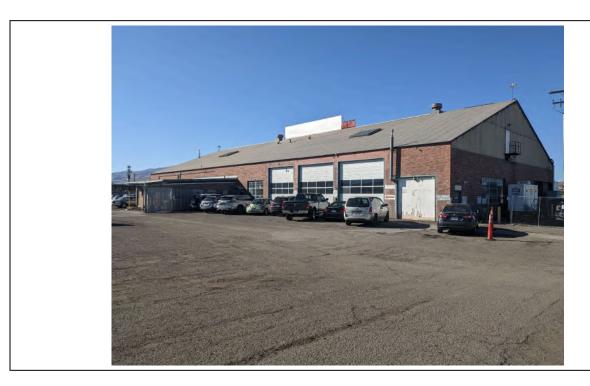
Elevation: Building 2 South elevation Date: 10/4/2022 Direction facing: 310 Photographer: S Rathbone

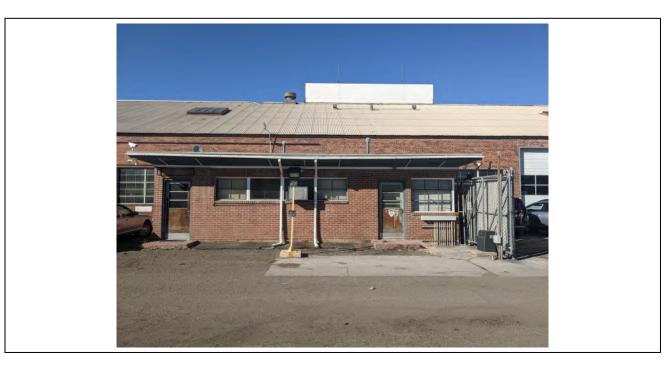
The office addition extending from the center of the front facade features a wooden door with three horizontal lights in the upper half at the western corner, accessed from a wide concrete step. East of the door is a row of four adjacent metal frame 4-light awning windows, with one of the windows now housing a small air conditioning unit. Further east there is a second wooden door with three horizontal lights in the upper half, accessed from a wide concrete step. At the east of the wall there is a metal frame 9-light industrial style window with the upper 6-lights being an awning

Elevation: Building 2 Front Wall Addition Date: 10/4/2022

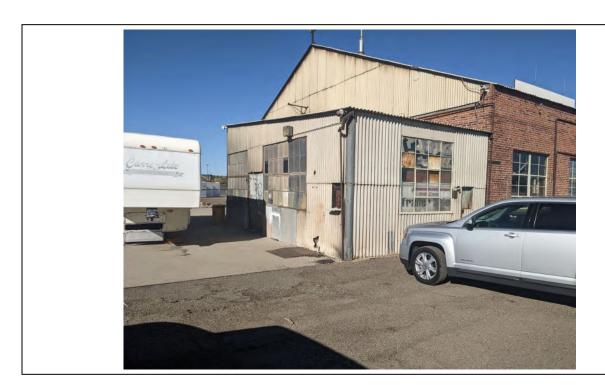
The northern side of the addition on the western gable wall extends up to the base of the gable, and its roof slopes down to the south. The walls of the addition are clad in corrugated asbestos-cement panels, with some replacement galvanized corrugated sheets. The northern wall features a centrally positioned metal frame 32-light industrial style window with a 4-light center pivot panel. The western wall features a centrally positioned wide plain metal door, flanked by two metal frame-

Elevation: Building 2 West Wall Addition

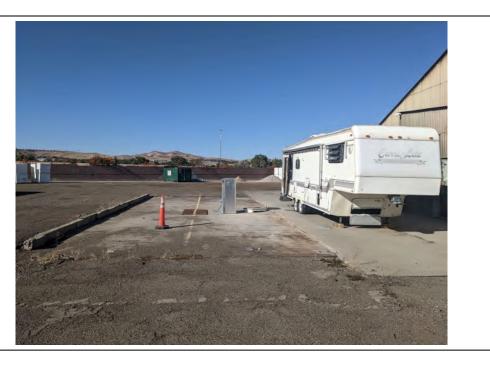
Building 2 is a large rectangular side gabled, metal frame, brick walled mechanics garage. The long axis of the two-story building is aligned east to west, and it is set upon a concrete pad foundation. The building is located to the west of Threlkel Streel in the central part of the original freight yard. According to the Washoe County Assessor the building was constructed in 1946, and the building is visible in an aerial photograph dated to that year. Nova Geotechnical & Inspection Services recently produced a Phase 1 Environmental Site Assessment report of the site and identified Building 2 as having been constructed in 1942 (Nova Geotechnical & Inspection Services 2020:16). When originally constructed the building had a long and thin protruding boiler room in the center of the northern wall. By 1953 the building had acquired a small addition on the southern part of the western side wall, and by 1962 a single-story office block had been added to the center of the southern wall. By 1966 a small free-standing garage building had been constructed immediately west of the building. The small free-standing garage was demolished at some point after 1999, leaving only low concrete foundations.

Elevation: Building 2 External Garage Foundations Photographer: S Rathbone Date: 10/4/2022

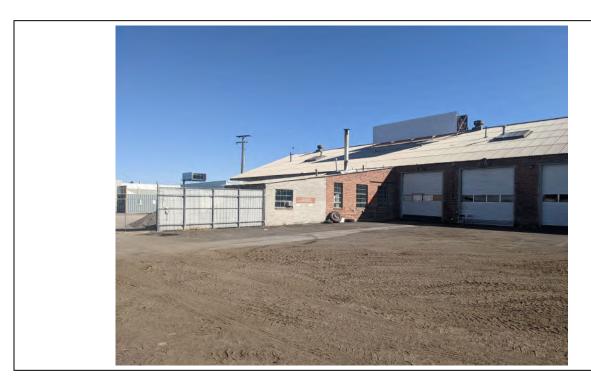
The northern rear wall is divided into two equally sized parts by the long and thin projecting boiler room that extends out to the north. The western section of the rear wall features four large garage bay doors with replacement overhead roller doors. The eastern section of the rear wall features four large garage bay doors with replacement overhead roller doors. At the eastern corner there is a smaller garage bay door which features a wooden 30-panel door, with 12-lights in its upper panels. The door is now permanently closed, and a crude set of plywood shelves has been attached to the lower part of the door. Metal handles low down on the door indicate that it raised upwards, but the lifting mechanism could not be determined. It is likely that the similarly sized and positioned blocked garage bay at the east end of the front façade originally featured a similar 30-panel wooden door.

Elevation: Building 2 Boiler Room

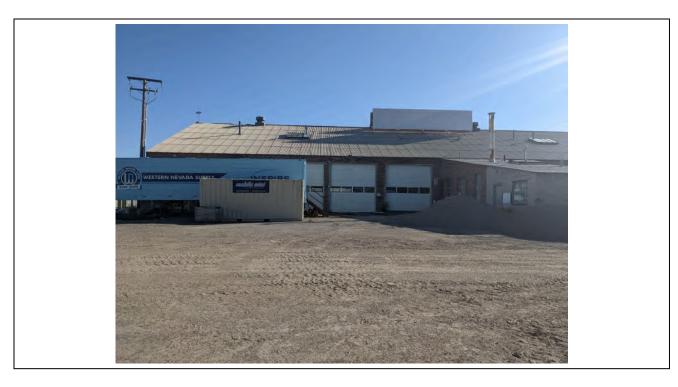
Elevation: Building 2 North elevation Date: 10/4/2022 Direction facing: 180 Photographer: S Rathbone

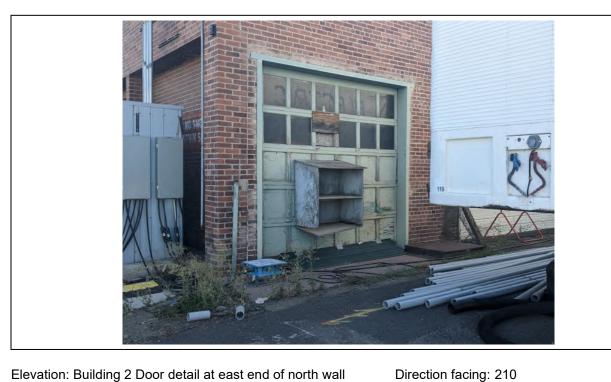
Elevation: Building 2 Door detail at east end of north wall Photographer: S Rathbone Date: 10/4/2022

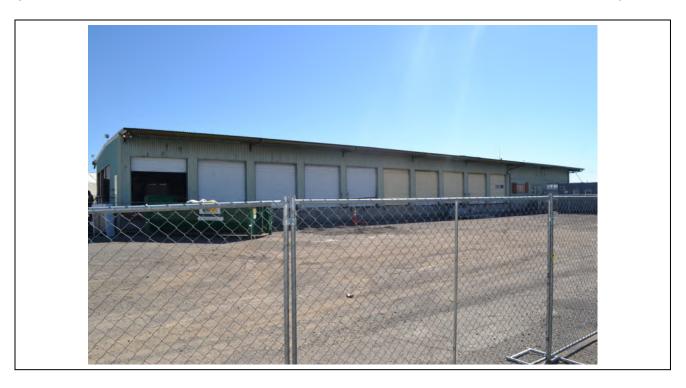
Building 3 is a large rectangular side-gable metal frame trucking transfer station. The building is clad with vertical ribbed metal siding, and it is set upon a raised concrete plinth foundation. The building is located to the east of Threlkel Streel, in the southwestern portion of the extension to the freight yard. According to the Washoe County Assessor the building was constructed in 1964, and the building is visible in an aerial photograph dated to 1966.

Elevation: Building 3 West elevation Date: 10/4/2022

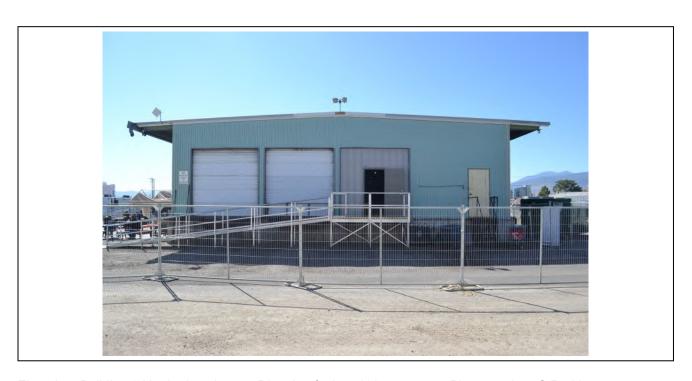
Elevation: Building 3 North elevation

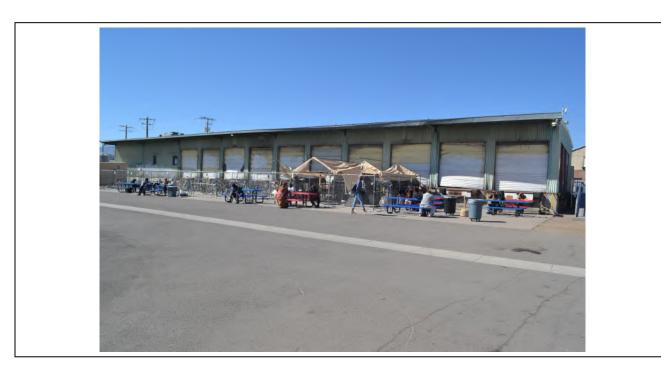
The rear wall at the east features ten regularly spaced large loading bay doors with overhead roller doors, which occupy most of the wall apart from the southern portion. The loading bay doors feature folding metal loading ramps with large rubber bumpers. The loading ramps are mounted at the top of the concrete plinth foundation, approximately four foot above the surrounding ground surface. The southern section of the wall, beyond the loading bay doors, features two medium sized metal frame 2-light sliding windows. The northern window is boarded up and the southern window is protected by a heavy metal mesh.

Elevation: Building 3 East elevation Direction facing: 200
