SEISMIC HAZARD INVESTIGATION – FAULT STUDY MULTI-FAMILY RESIDENCES PROJECT 6400 CHOCOLATE DRIVE SUN VALLEY, RENO, NEVADA APN 502-250-09

> PROJECT NO. R20215772E2 September 9, 2022

RE: Seismic Hazard Investigation – Fault Study Multi-Family Residences Project 6400 Chocolate Drive Sun Valley, Reno, Nevada APN 502-250-09

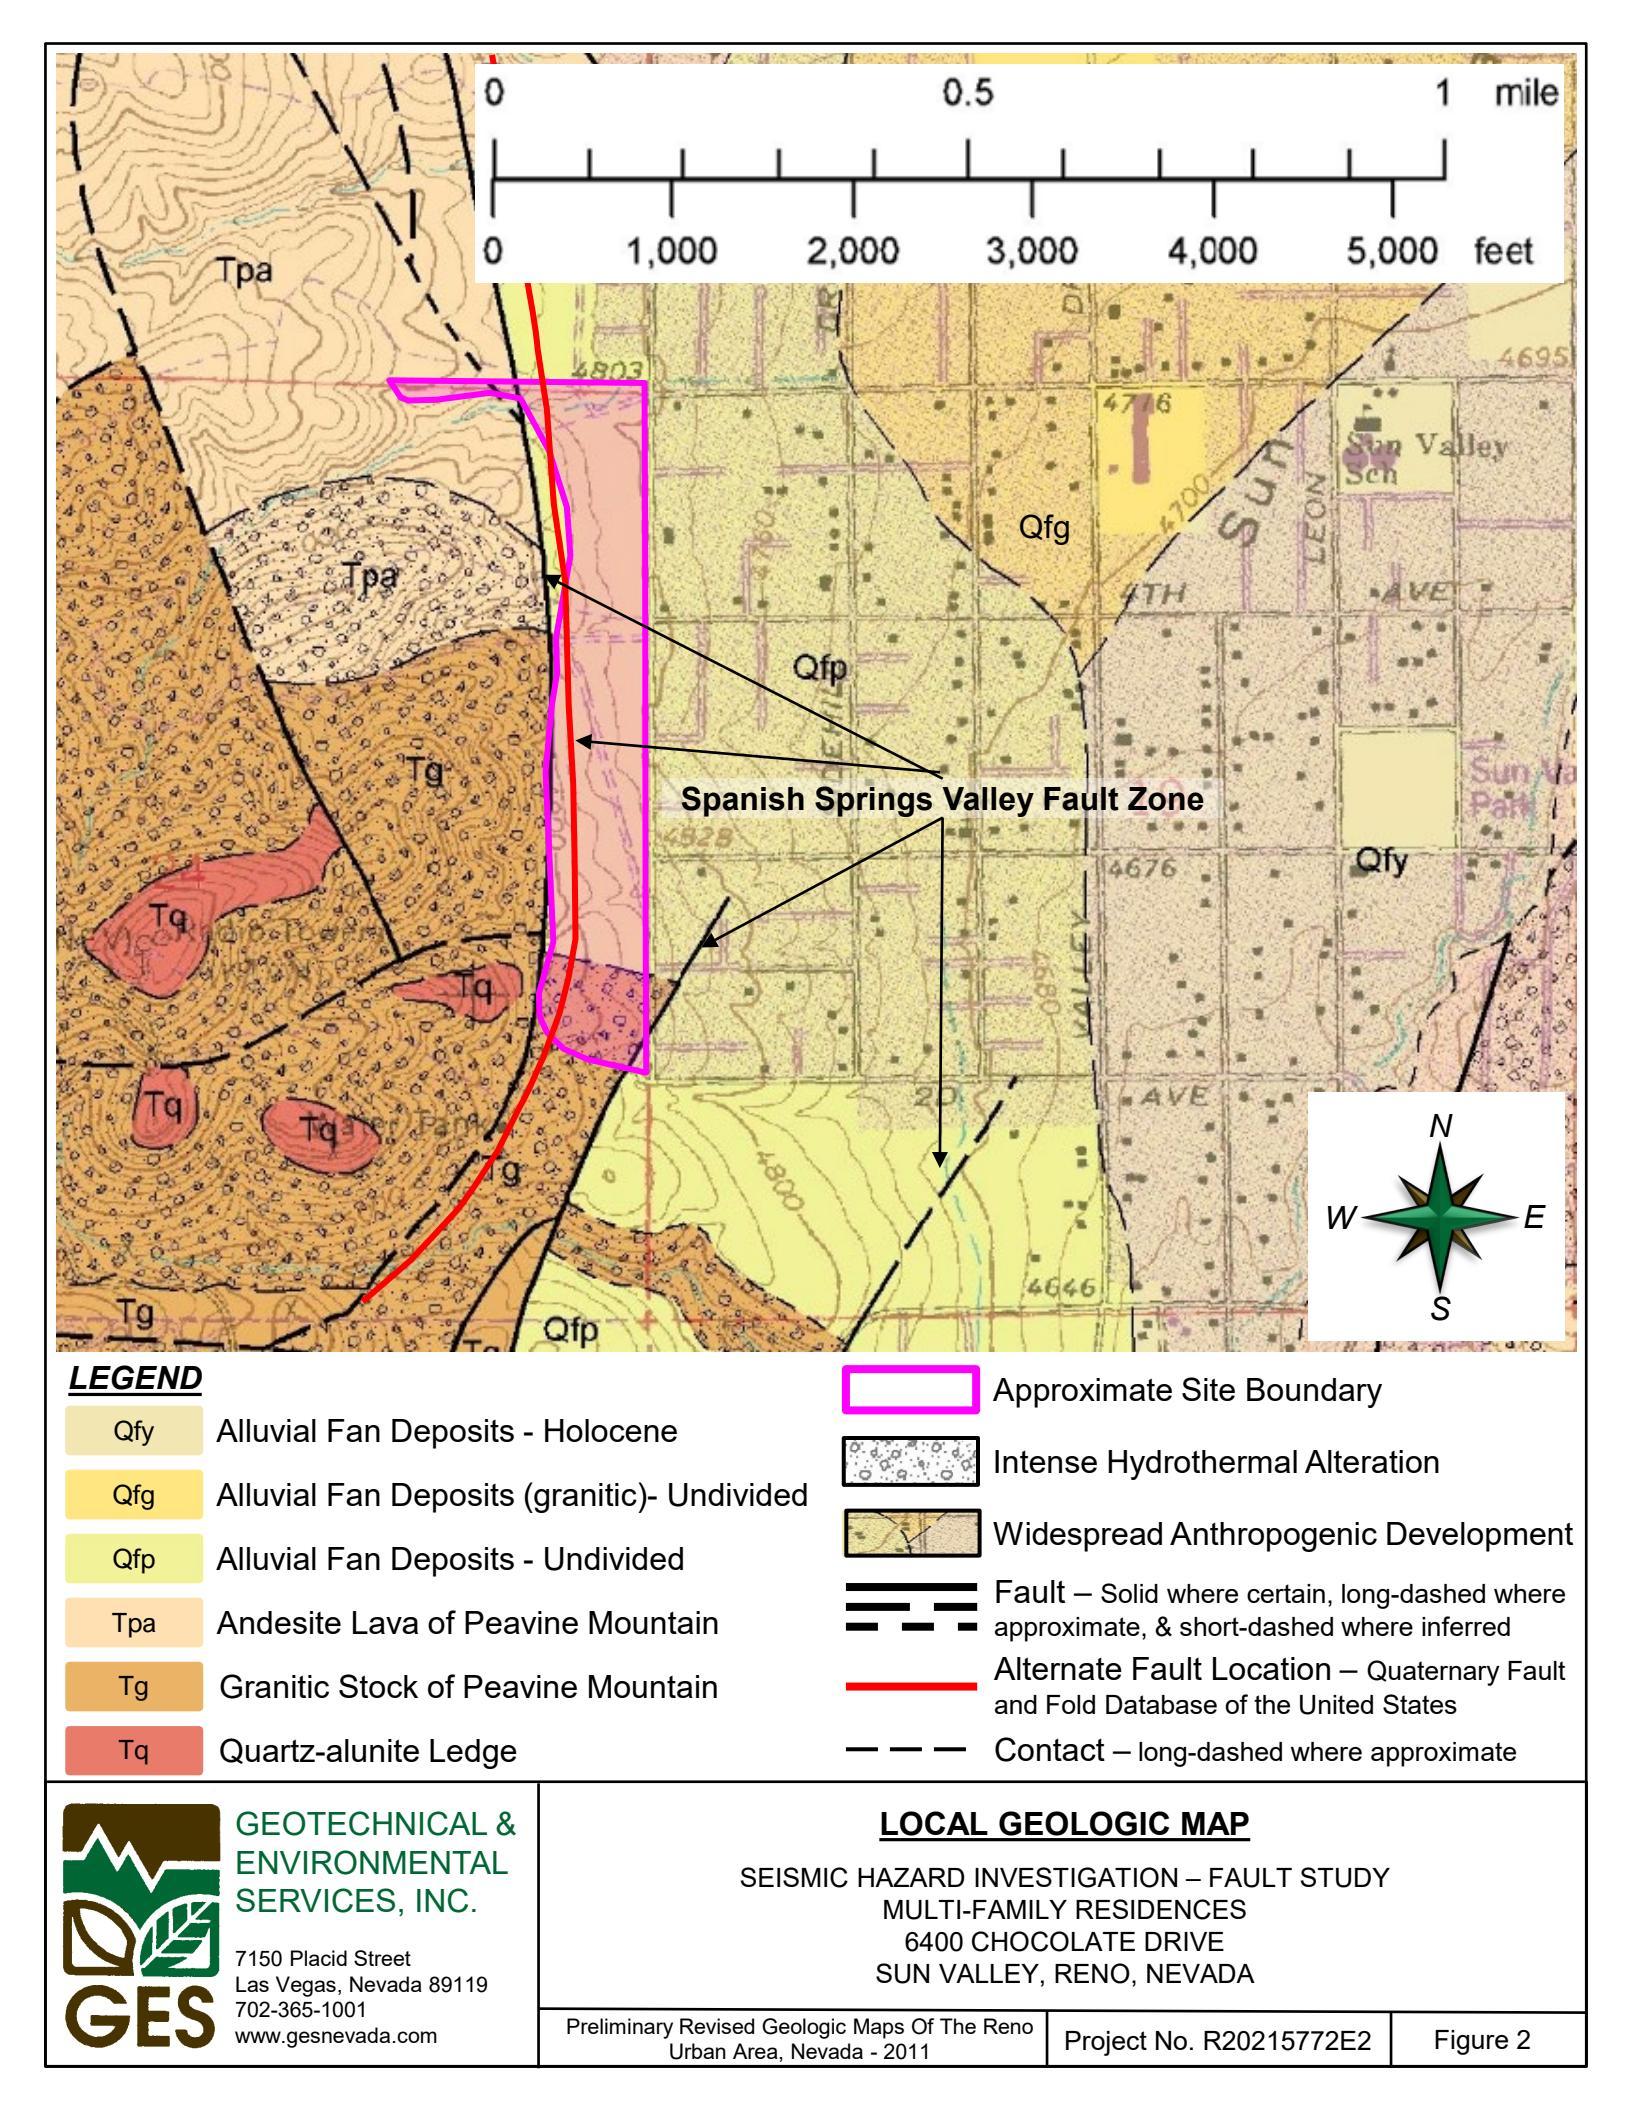
indications of fault surface ruptures were observed on or immediately adjacent to the project site, surficial geologic features (i.e., eroded scarps) were interpreted generally in the western portion of the site. Our interpretation of site geologic and physiographic features at the project site are presented on Figure 3, Conceptual Site Plan and Geologic Map.

Recommended 50 foot **Building Setback Line**
