Swan Lake Closed Hydrobasin Update

August 27th BCC Staff Report

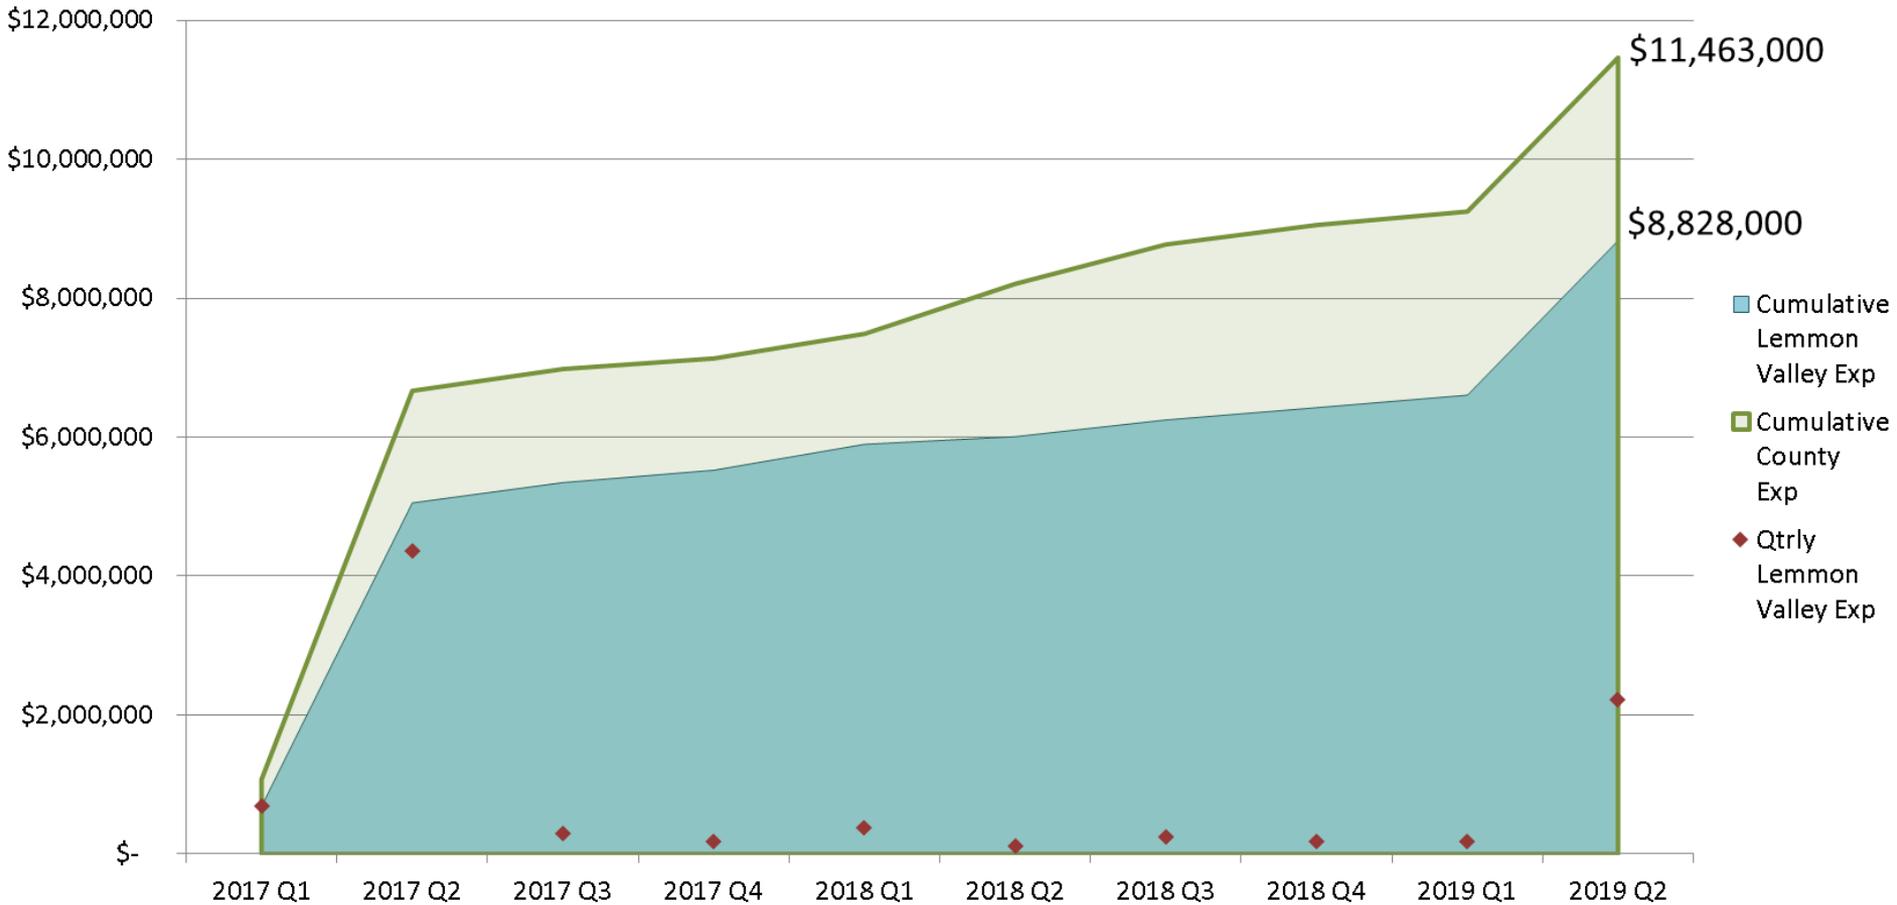
Washoe County Flood Expenses - As of June 30, 2019

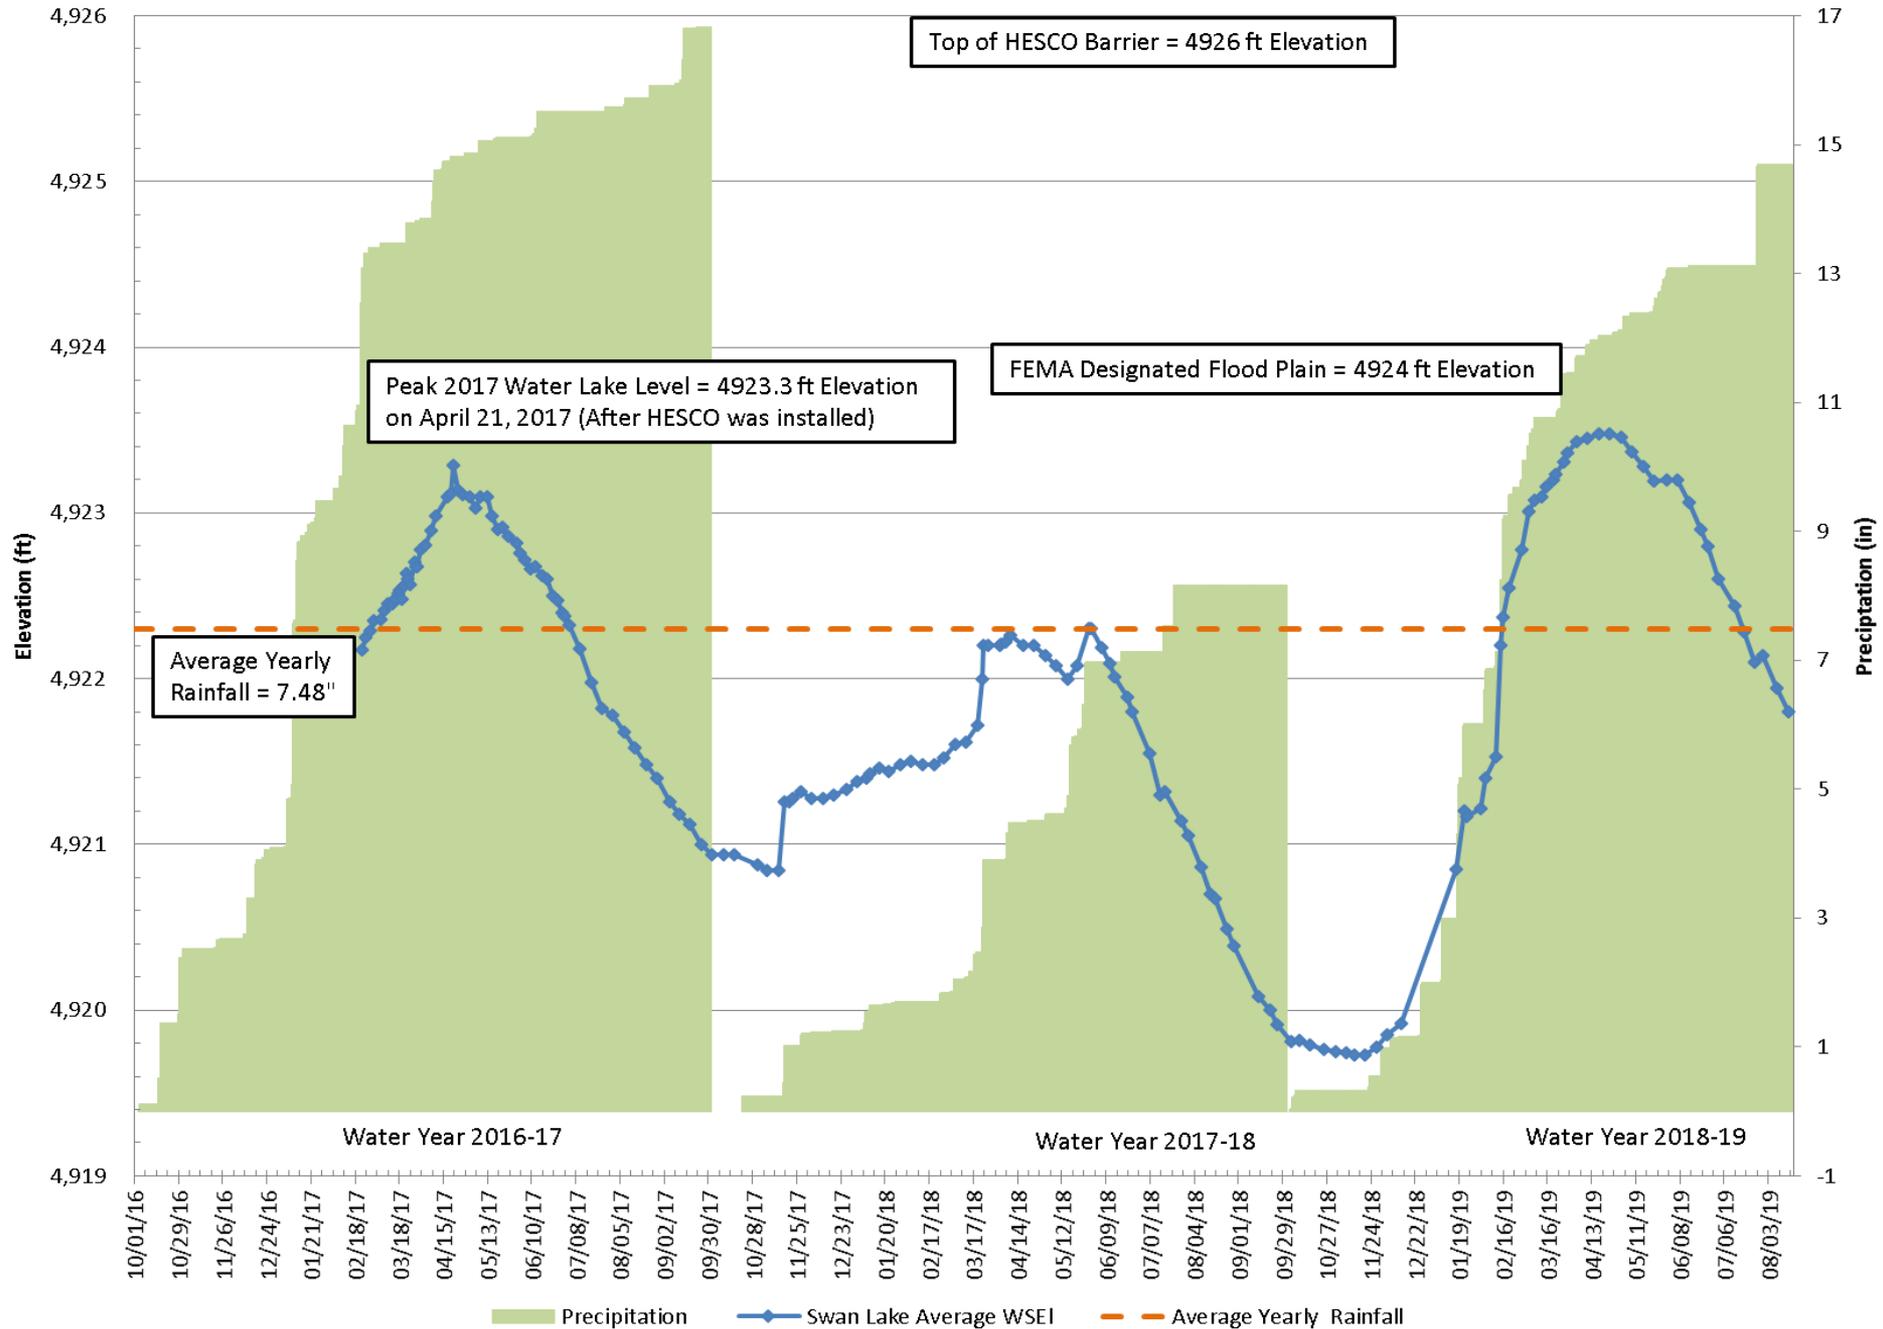
Swan Lake Water Elevations 2017-19

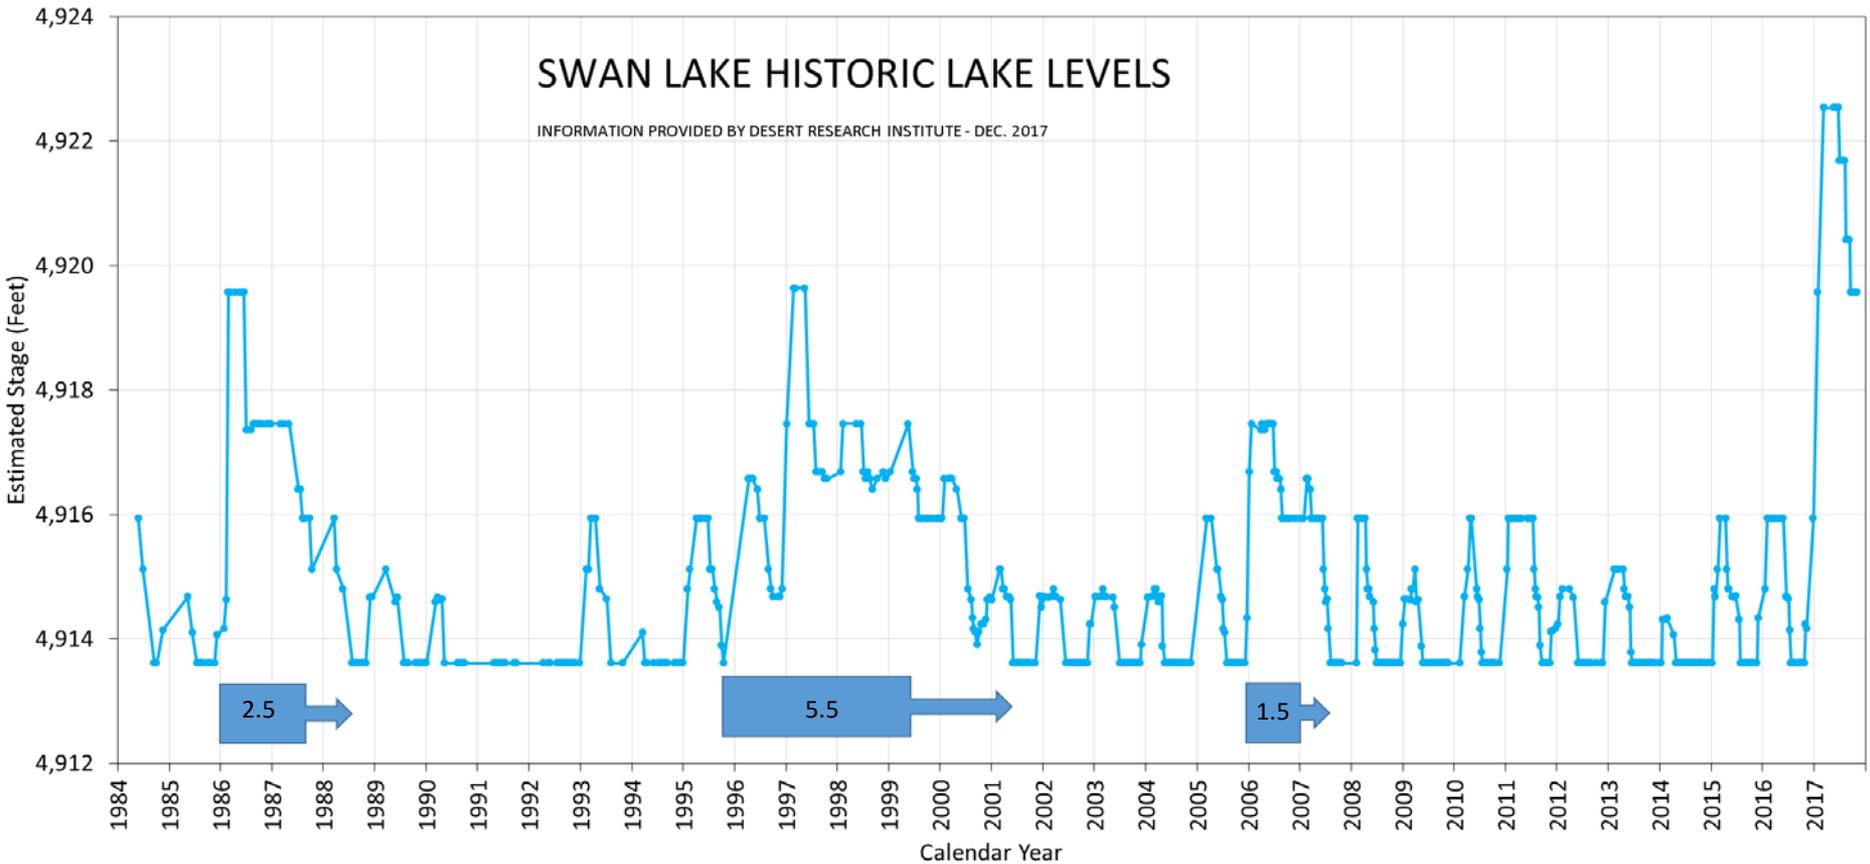
East Lemmon Valley Hydrographic Basin

SWAN LAKE HISTORIC LAKE LEVELS

INFORMATION PROVIDED BY DESERT RESEARCH INSTITUTE - DEC. 2017
